Project 5371
21 August 2023

ST IGNATIUS COLLEGE WINGARU PROJECT – VIBRATION MONITORING – WEEKS 1-4
SUMMARY OF VIBRATION MONITORING RESULTS

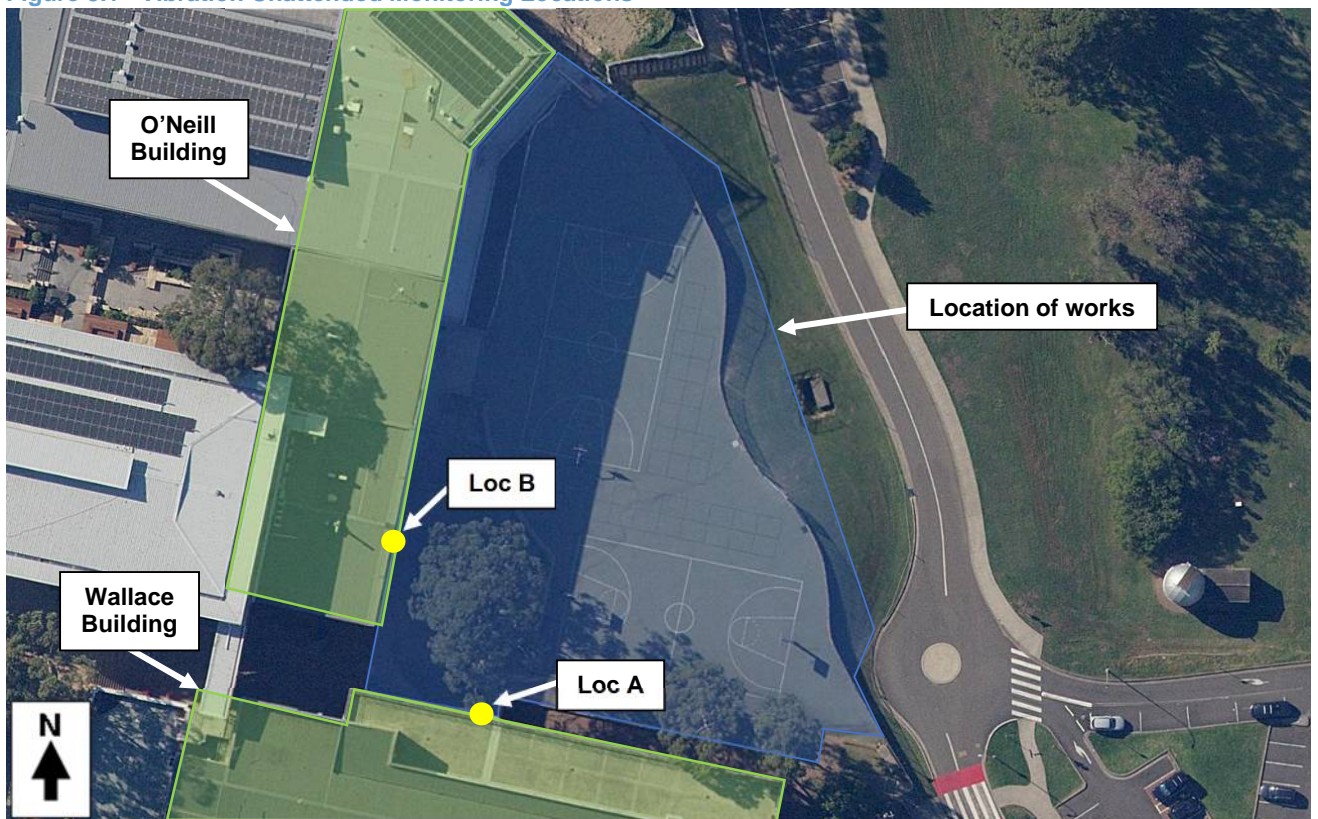
Figure 3.1 –Vibration Unattended Monitoring Locations

At the request of Belmadar, Acoustic Dynamics attended the subject site on 10 July 2023 and installed two unattended vibration loggers on the O’Neill building to the west, and the Wallace Building to the south of the works, to monitor vibration exposure levels resulting from demolition and excavation works associated with the subject site. We note the locations were chosen

The unattended vibration logger were installed to assess transmitted vibration from the subject site, and its compliance with the relevant criteria. Acoustic Dynamics notes that measured vibration levels are likely higher than levels received by the adjacent properties, as the monitors are sometimes in locations that are coupled to the structures being demolished within the subject site, while also being marginally closer to the works.
