Project 5371
15 September 2023

ST IGNATIUS COLLEGE WINGARU PROJECT – VIBRATION MONITORING – WEEKS 5-8
SUMMARY OF VIBRATION MONITORING RESULTS

The subject site is located on Tambourine Bay Road, Lane Cove NSW.

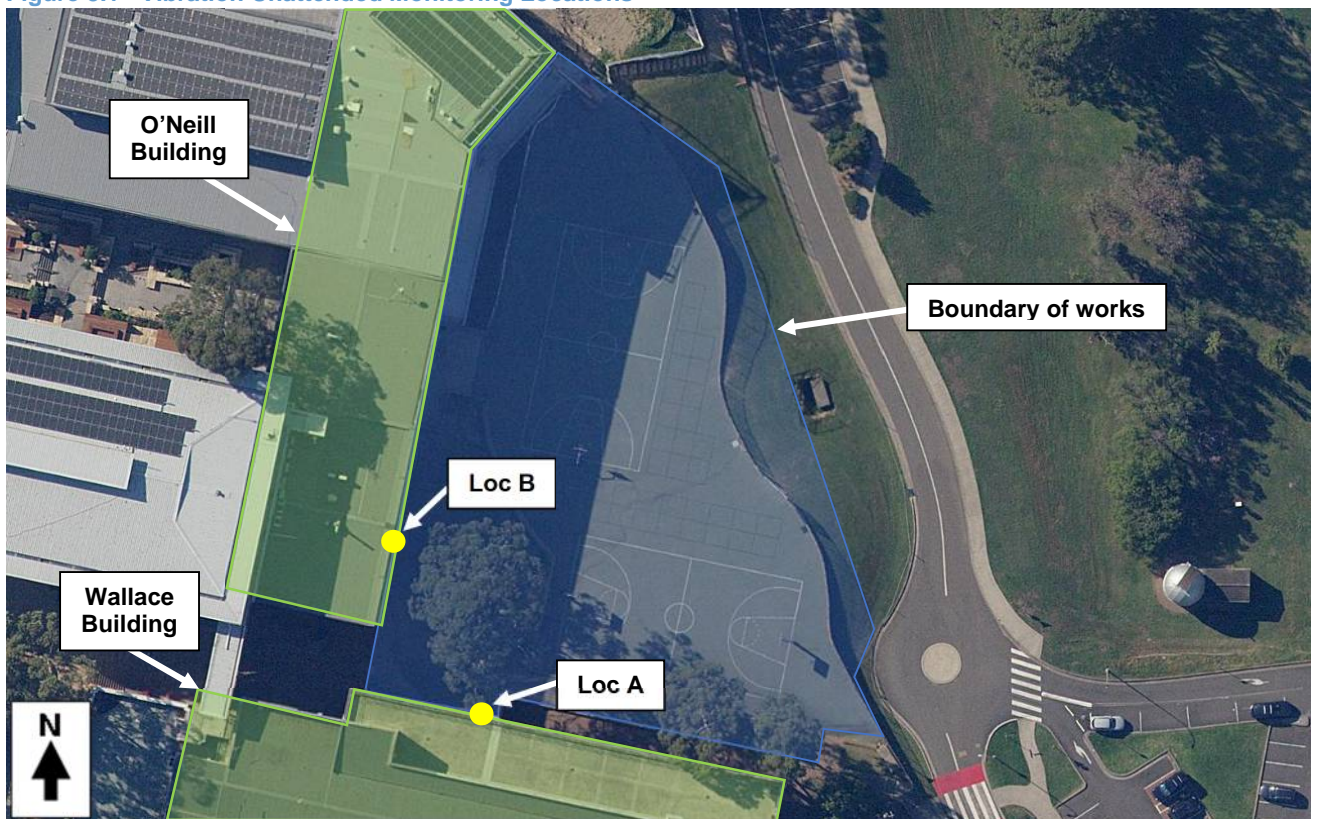
Figure 3.1 –Vibration Unattended Monitoring Locations

At the request of **Belmadar**, Acoustic Dynamics attended the subject site on 10 July 2023 and installed two unattended vibration loggers on the O’Neill building to the west, and the Wallace Building to the south of the works, to monitor vibration exposure levels resulting from demolition and excavation works associated with the subject site. We note the locations were chosen

The unattended vibration logger were installed to assess transmitted vibration from the subject site, and its compliance with the relevant criteria. Acoustic Dynamics notes that measured vibration levels are likely higher than levels received by the adjacent properties, as the monitors are sometimes in locations that are coupled to the structures being demolished within the subject site, while also being marginally closer to the works.
